Safety notice (EN) | NEO Container

Doussard (France), January 15, 2018

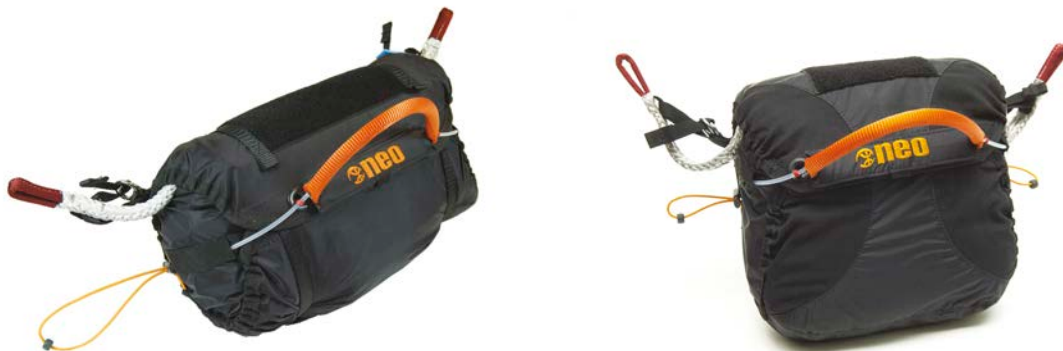
The handle of the external NEO Container can loose the connexion with its pin (plastic rod).
The problem may happen after several month or year of use.

To solve this problem, NEO is replacing all rescue handles of the NEO Container delivered.
The original handle, on the left, is replaced by this new one, on the right :

Thanks to contact your dealer to get your rescue container handle replacement:

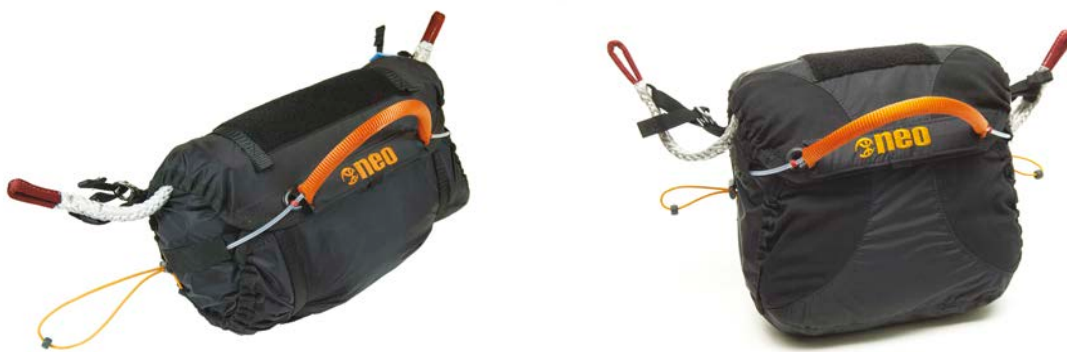
La poignée du Container externe de parachute de secours NEO peut se désolidariser de son jonc. Ce problème peut arriver après plusieurs mois ou années d'utilisation.

Pour résoudre le problème, NEO remplace toutes les poignées de secours.

Merci de contacter votre revendeur pour obtenir votre poignée de remplacement :

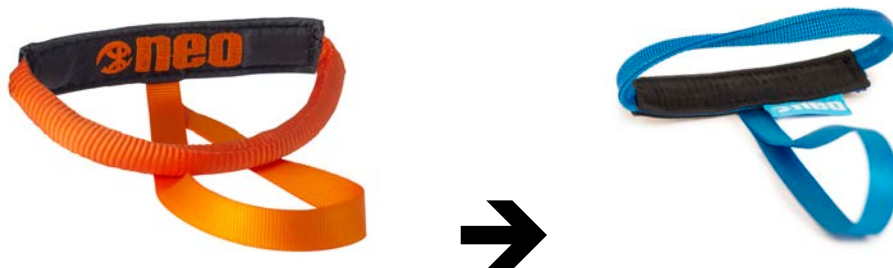
La poignée d'origine, ici à gauche, sera remplacée par la nouvelle poignée à droite :
